FLORIDA POWER & LIGHT

**TURTLE POINT WATER QUALITY IMPROVEMENT
PROJECT BIOLOGICAL EVALUATION AND
RESTORATION PLAN**

July 2016

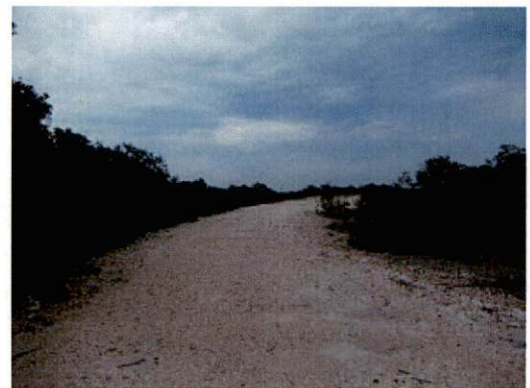
Photo 3-1. Proposed staging area

Staging areas are available near the project site. Photo 3-1 provides an example of a potential staging area; however, the staging area will be identified by the contractor. Fill material will be delivered via truck directly to the staging area along existing roads on the project site.. Fill material will be stored on site. Fill material will be staged in a contained environment to avoid loss of material to adjacent aquatic resources. The staging area will be returned to pre-project conditions following project completion, with final cleanup notification provided to the FPL representative.

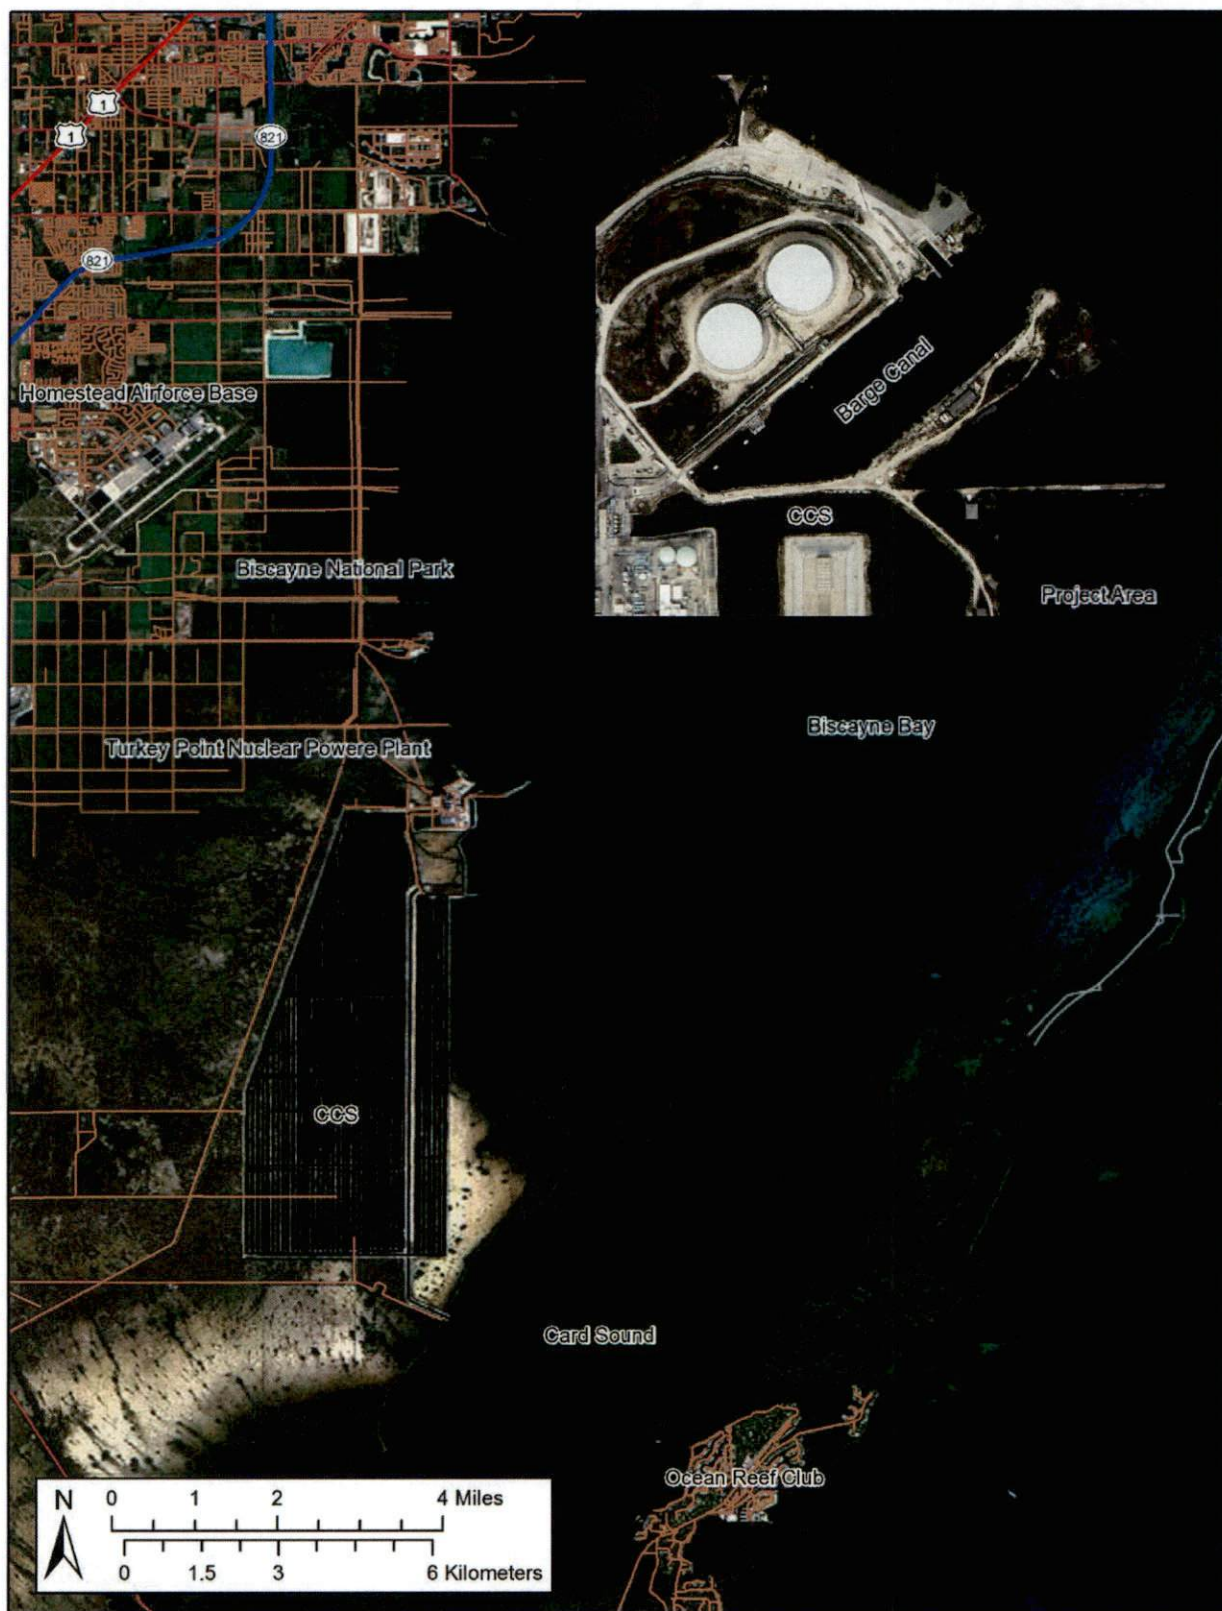
Figure 1-1. Project vicinity map

Tetra Tech Inc., (Tetra Tech) was contracted by Florida Power & Light (FPL) to provide an ecological evaluation and restoration plan for the Barge Canal/Basin Water Quality Improvement Project (Project), located at the Turkey Point Nuclear Power Plant in Homestead, Miami-Dade County. The Project is intended to restore water quality within the active Barge Canal/Basin (BC) by backfilling to -15 NAVD. Figure 1-1 presents the project location graphically.

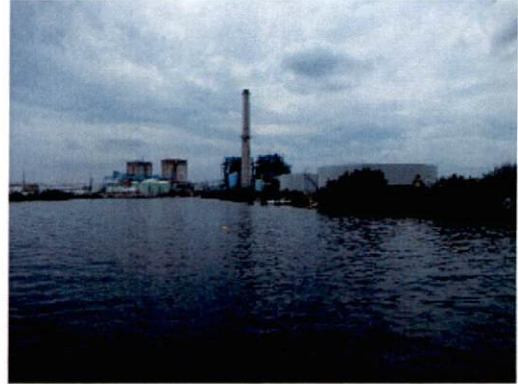
No epibenthic cover was documented within the BC at depths greater than 15 fsw. In general, barren substrate or epibenthic cover (macroalgae) of less than <5% was encountered to the proposed fill depth of -15 ft. NAVD. Silt-covered filamentous diatoms makes up the dominant vegetative cover along the hard substrate (wall and rubble and/or concrete). Macroalgae cover was occasionally observed in areas of gently sloping unconsolidated substrate predominantly in the -4 to -7ft. elevation range. Table 2-2 provides a list of SAV documented during the survey.

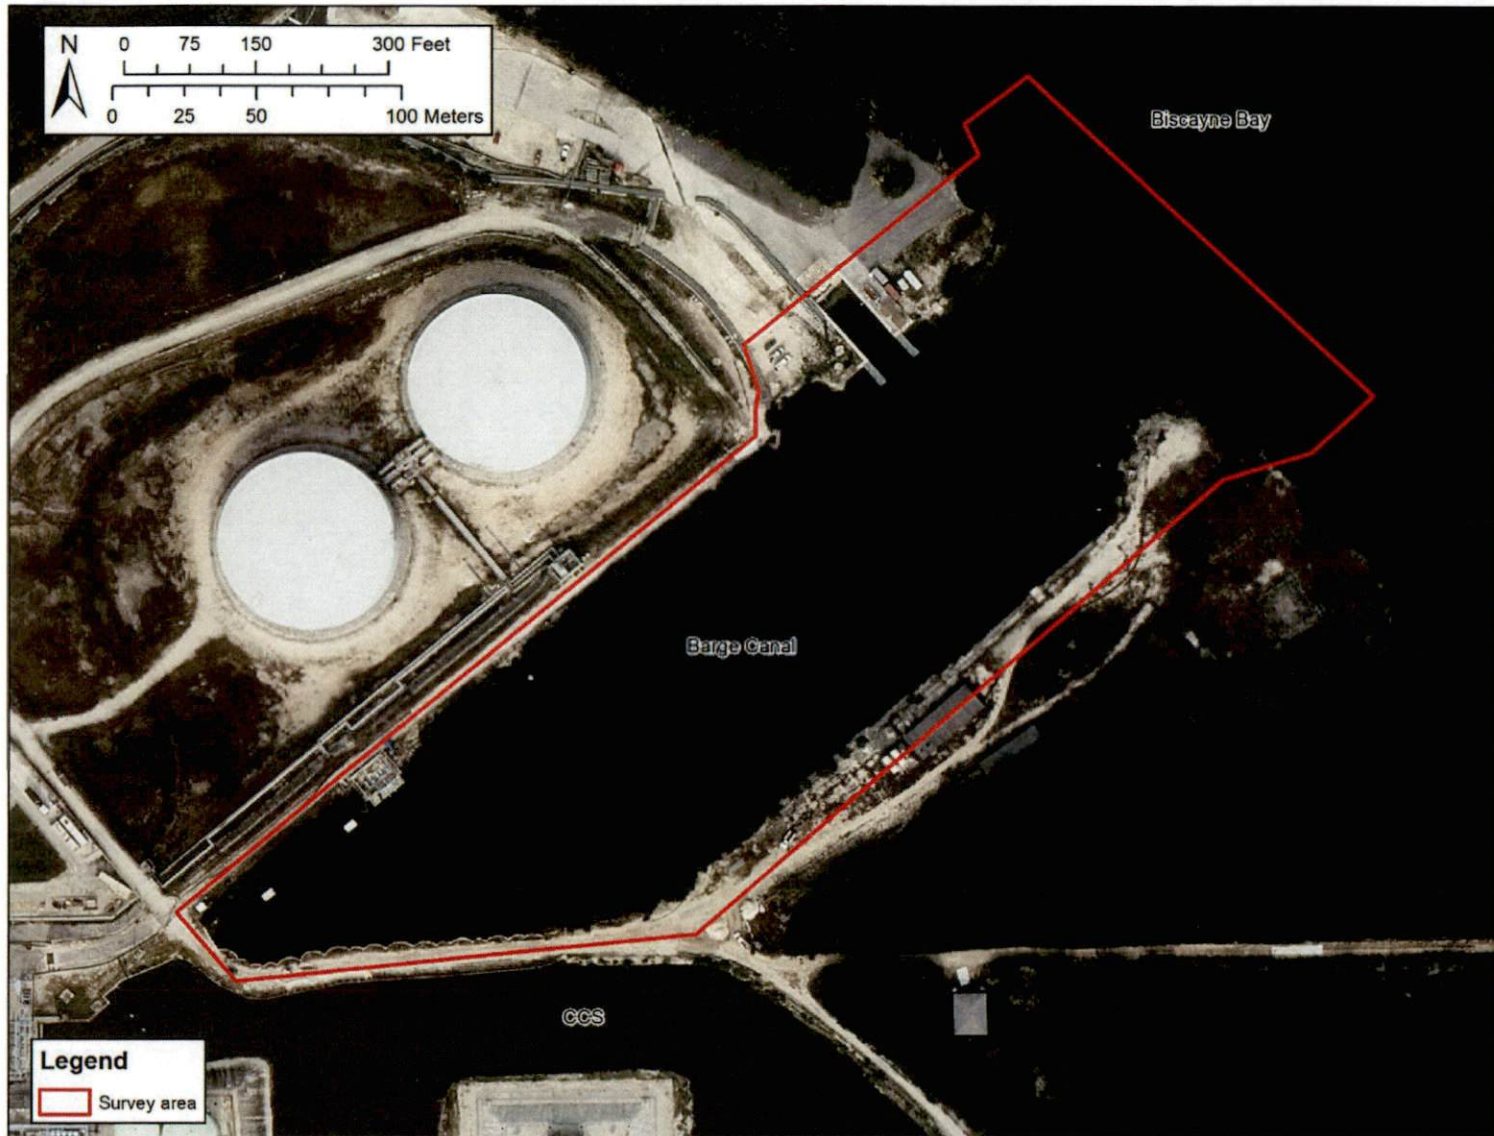
Figure 2-1. Extent of survey

Tetra Tech biologists with experience in benthic and mangrove habitat assessments performed a biological evaluation of the BC and surrounding areas. Figure 2-1 provides the extent of the assessment area. The evaluation included reconnaissance of the BC, the confluence of the BC and Biscayne Bay, and the immediately adjacent mangrove and terrestrial communities. All observations were made from the surface aboard a vessel. The entire boundary of the BC was surveyed. During the survey submerged aquatic vegetation (SAV) communities and presence of marine fauna were noted. Mangrove and terrestrial communities were also assessed and an inventory of common species and wildlife utilization were documented. Representative images including underwater video of resources were captured during the assessment.

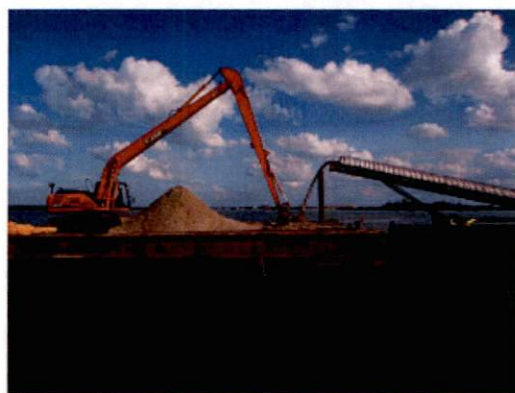
Photo 3-2. Fill conveyor loading placement barge

Loose fill may be transferred using a long-reach excavator and conveyor system or other suitable transfer machinery from the staging area to a material placement barge. Photo 3-2 provides an example of equipment used to efficiently transfer fill material. Typically, the use of a conveyor system provides a low-to no-impact fill material transfer route through the mangroves. Mangrove canopy openings sufficient for installation of the conveyor system were identified during the site assessment. Figure 3-2 identifies a potential location for installation of the conveyor system. All sections of the conveyor system that cross mangrove habitat or any other sensitive habitat will be covered from above and below to limit wind loss of material and to catch any material that may drop from the conveyor system. The covers are generally constructed of half sectioned corrugated style pipe installed above and below the conveyor belt (see Photo 3-2). Once selected the contractor may propose comparable alternative methods.

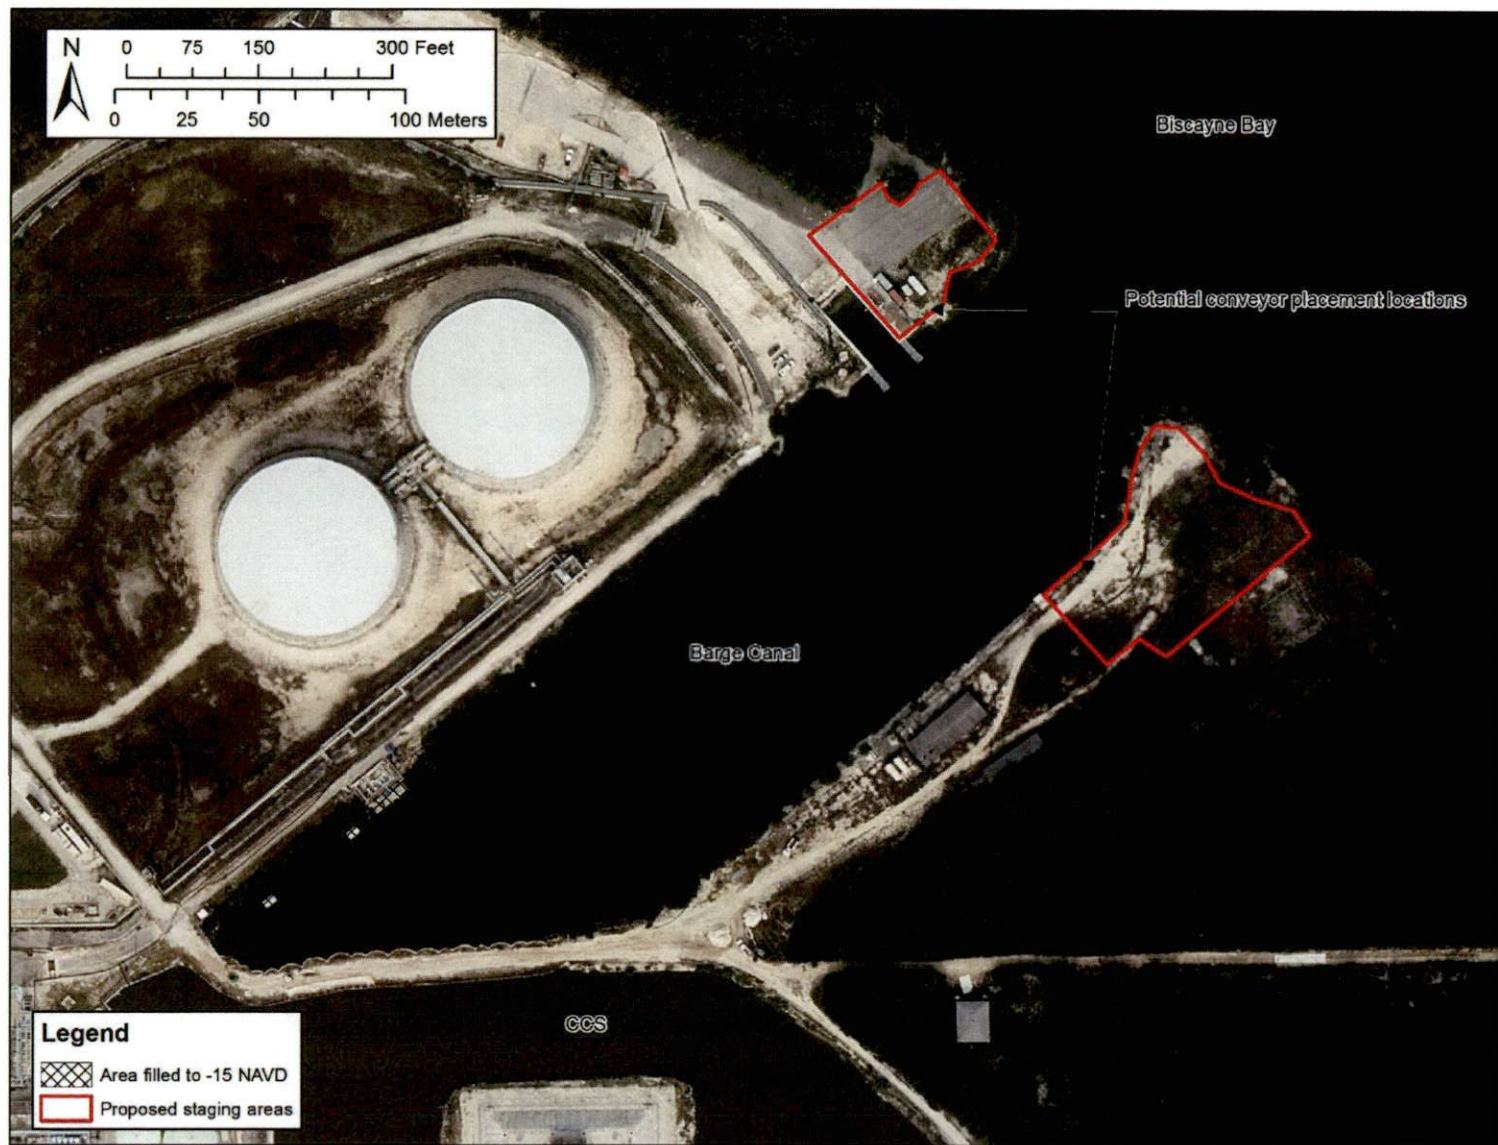
Figure 3-1. Fill area and proposed staging area and conveyor placement area

The BC was evaluated to determine the work zone, vessel access corridor, the appropriate methods for delivery and transfer of fill material, placement of the fill material, and turbidity containment. The proposed fill elevation was determined by a separate study for water quality improvement planning. Figure 3-1 illustrates the fill area planned to -15 NAVD. The proposed approach and methods for topographic restoration are described below. A set of conceptual restoration plan drawings have been prepared under a separate cover.

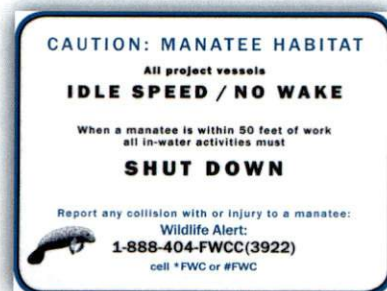
Figure 3-3. FWC manatee signage

All staff involved with filling operations will be instructed and trained as per Florida Fish and Wildlife Conservation Commission (FWC) Standard Manatee Conditions for In-Water Work as well as the National Oceanic and Atmospheric Administration's National Marine Fisheries Service (NOAA-NMFS) Marine Sea Turtle and Smalltooth Sawfish Construction Conditions. Idle speed/manatee protection signage will be maintained on board during all restoration activities. One sign which reads Caution: Boaters shall be posted in a location where it is prominently visible to all staff. A second sign measuring at least 8.5 by 11-in. explaining the requirements for "Idle Speed/No Wake" and the shutdown of in-water operations (Figure 3-3) will be posted in a location prominently visible to all personnel engaged in water-related activities (www.myfwc.com). Signage will be maintained at both the location of the materials barge and the restoration site. If any Threatened and Endangered Species comes within 50 feet of the work zone, filling operations will cease until the protected species has left the work zone on its own accord.
