In the Matter of:)
Florida Power & Light Co.) Docket No. 50-389
St. Lucie Plant, Unit 2)

I certify that on November 6, 2014, I served copies of the foregoing SOUTHERN ALLIANCE FOR CLEAN ENERGY'S MOTION FOR LEAVE TO AMEND HEARING REQUEST WITH SECOND SUPPLEMENTAL DECLARATION OF ARNOLD GUNDERSEN on the parties to this proceeding by posting it on the NRC's Electronic Information Exchange.

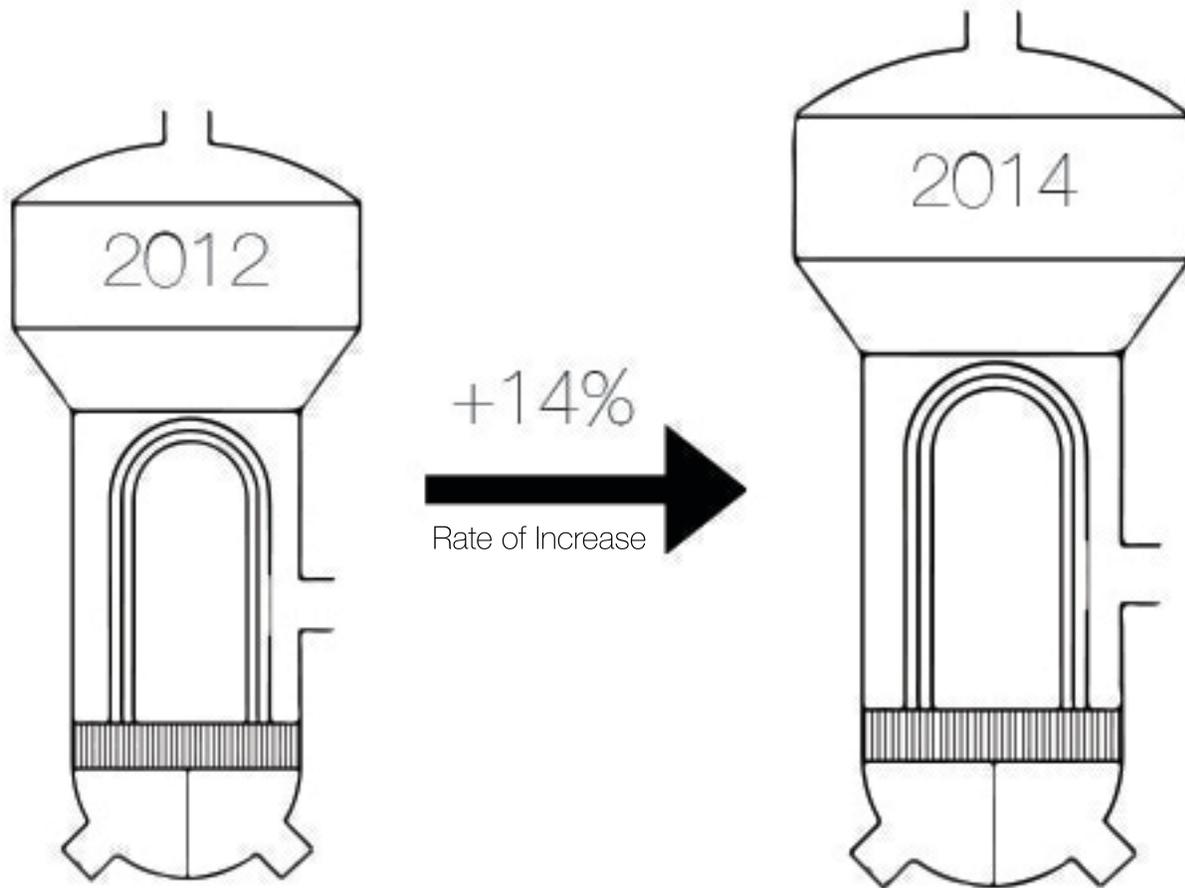
Table 1

St. Lucie Unit 2 : **A** Steam Generator Tube Denting Indications

Total Steam Generator Tubes with Tube Denting Indications at Anti-Vibration Bar

Year	Steam Generator	# of tubes	% of tubes (8,999 total)	Change since previous year	% Increase over previous inspection
2012	A	2,809	31%		
2014	A	3,207	35%	+398	14%

16. The cumulative steam generator degradation in Unit 2 is also a matter of serious safety concern. In March 2014, the cumulative degradation in SG A was 35% of all tubes, and the cumulative degradation in SG B was 22% of all tubes. These are astronomical figures, considering that most steam generators experience almost no degradation. The high level of cumulative degradation, combined with the fact that some degradation continues, raises the concern that a fundamental design problem is causing the degradation. Unless and until FPL and the NRC Staff conduct a thorough analysis of the RSG designs and how the rate of degradation could be stopped or significantly slowed, it is reasonable to assume that it will continue. As a result, it is also reasonable to assume that the safety

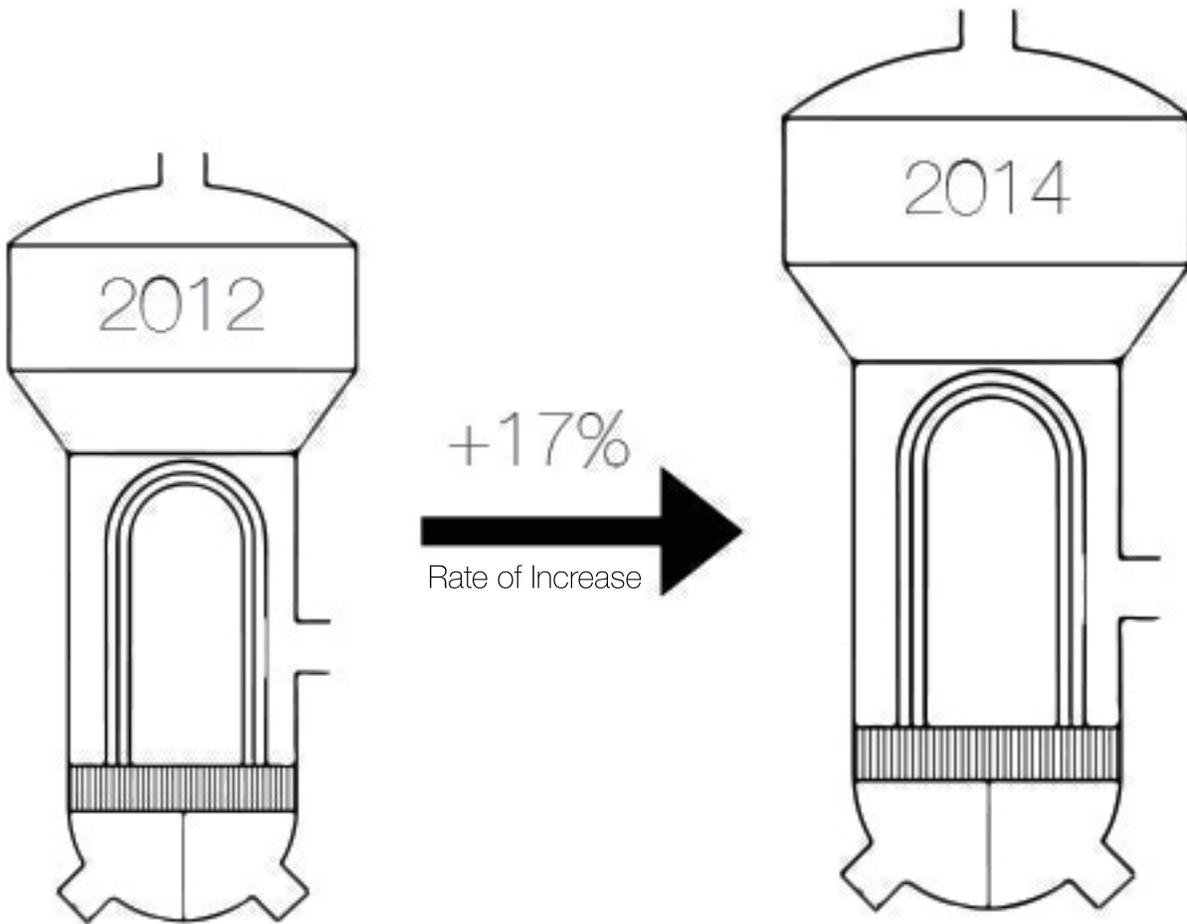
Table 2

St. Lucie Unit 2 : **B** Steam Generator Tube Denting Indications

Total Steam Generator Tubes with Tube Denting Indications at Anti-Vibration Bar

Year	Steam Generator	# of tubes	% of tubes (8,999 total)	Change since previous year	% Increase over previous inspection
2012	B	1,656	18%		
2014	B	1,938	22%	+282	17%

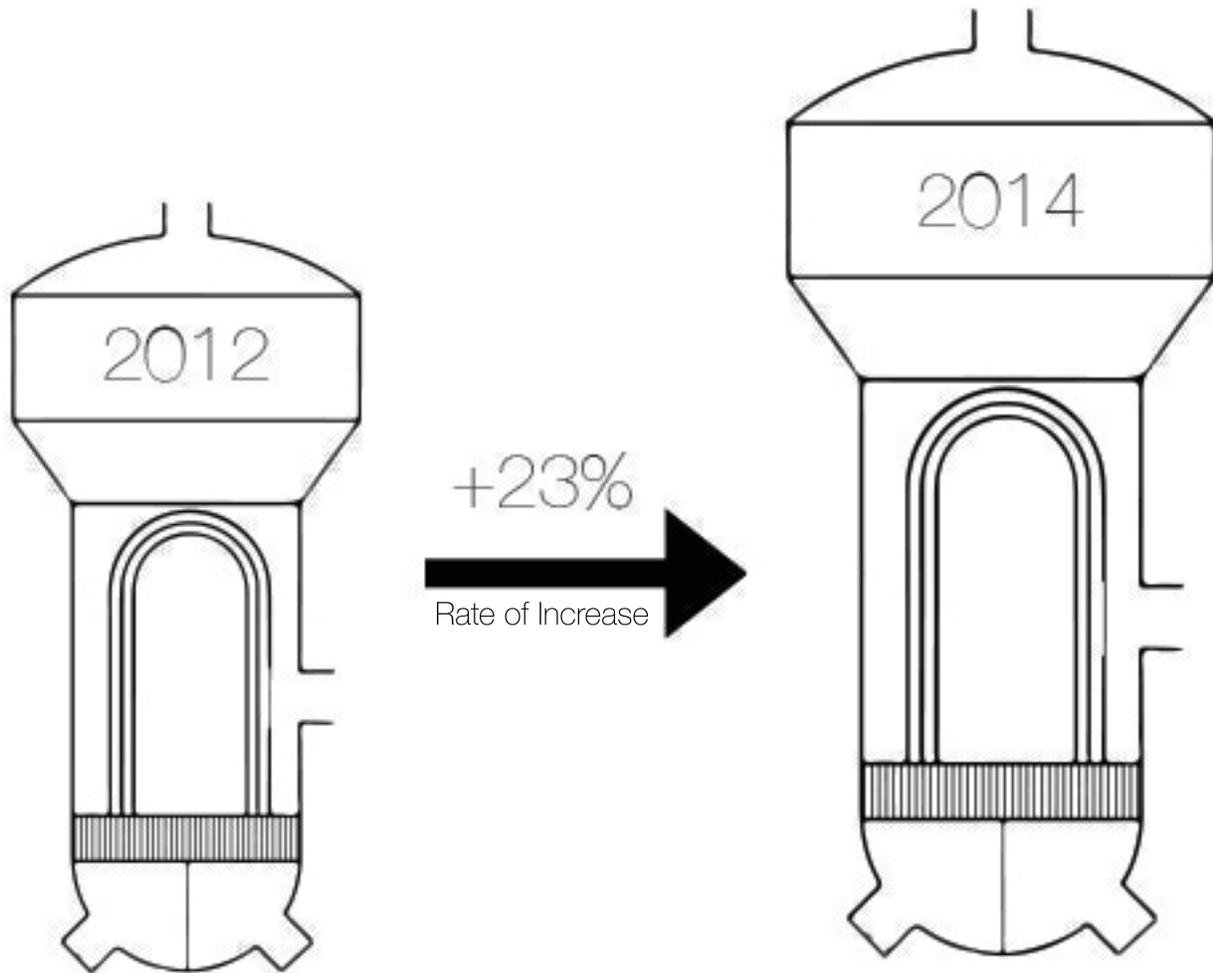
Table 4

St. Lucie Unit 2 : **B** Steam Generator
 Serious Tube Damage

Steam Generator Tubes with Serious Anti-Vibration Bar Damage (> 20%)

Year	Steam Generator	# of tubes (8,999 Total)	% of tubes	Change since previous year	% Increase over previous inspection
2012	B	126	1.4%		
2014	B	157	1.7%	+31	23%

17. An additional safety concern is raised by the fact that a significant portion of SG A tubes are seriously damaged.
 - 17.1. While the damage in SG B is less than the damage in SG A, the damage in SG B is still greater than that in any other steam generator in the country other than St. Lucie Unit 2 SG A. The data in the 2014 S.G. Inspection Report show that St. Lucie Unit 2 is operating with SG A and B as the most damaged steam generators at any operating nuclear power plant in the nation.

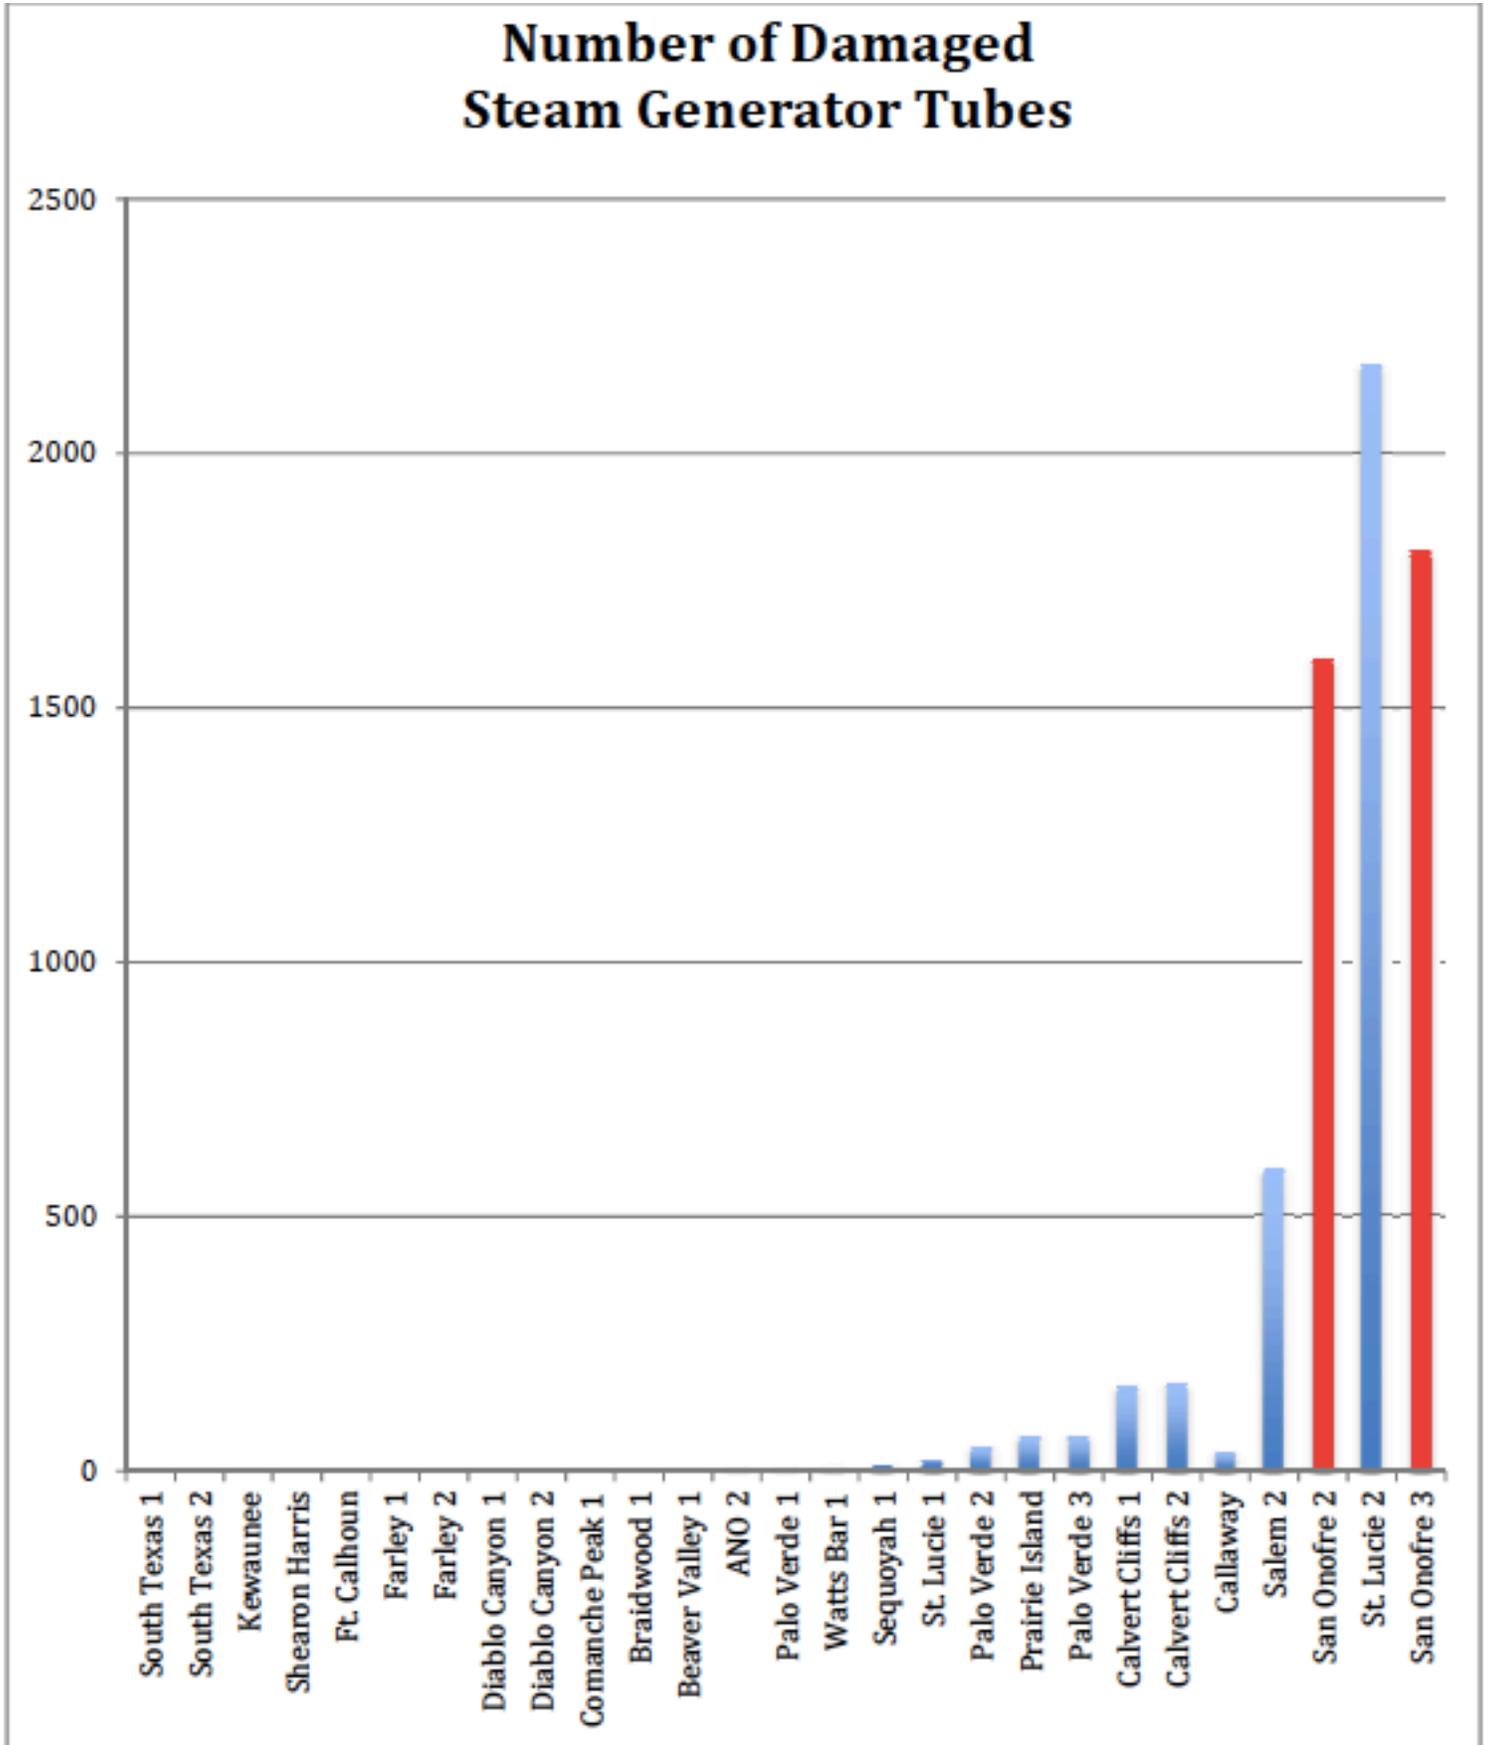
Figure 1: Number of Damaged Steam Generator Tubes, *FAR OUTSIDE THE NORM: The San Onofre Nuclear Plant's Steam Generator Problems in the Context of the National Experience with Replacement Steam Generators*, by Daniel Hirsch and Dorah Shuey with a Foreword by Dale Bridenbaugh, September 12, 2012, Figure 4, Page 14, <http://www.committeetobridgethegap.org>

14. I am concerned that the rate of steam generator tube deterioration in St. Lucie Unit 2, although decreased from previous outages, continues to be extraordinarily high compared to other steam generators nationwide. Figure 1 shows that most reactors experience little or no steam generator degradation throughout time periods of operation spanning decades. During the normal operating lifetime of a steam generator, the rate of degradation during its operating life is not likely to exceed 4% of the total tubes in the entire steam generator. In comparison, the percent of increased damage experienced by the St. Lucie Unit 2 SG A during just the last 18 months between inspections is 4% and the total damage in only 6-years is 35%.
